Queenstown | 03 442 3883

**HALF ROUND GUTTER**

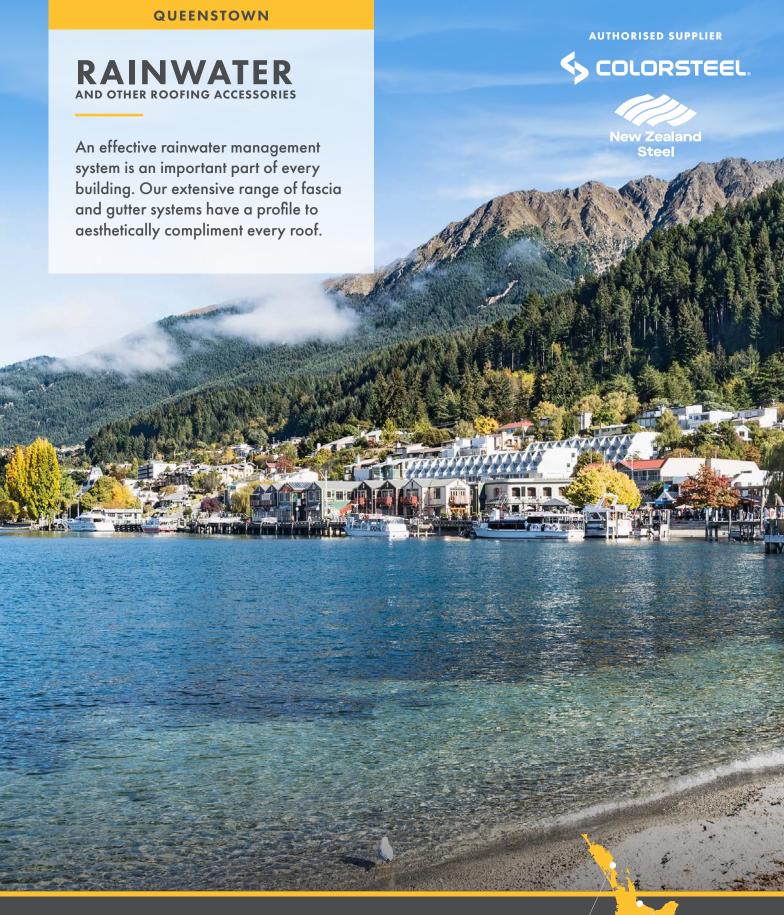
Half Round Gutter is a distinctive profile that adds class to the eave line of any dwelling and looks great when partnered with our long-run fascia and roof profiles.

Our roll top ridge capping prevents rain or water from entering the house via the apex of the roof. It also prevents rainwater from penetrating the lower levels of a roof, which can damage the entire roof structure. Freeman Roofing ridge capping comes in a full range of colours and is made from genuine NZ made Colorsteel®

Custom made box gutter can be made to any size you need for commercial purposes. A swage down the length of the gutter for strength and aesthetic purposes can also be added to suit your needs. Internal and external mounting brackets are available.

Quad gutter provides an attractive take on the traditional quarter round gutter, providing a bigger water flow capacity for higher rainfall areas. Quad's gently curved front and strong swaging offer a unique blend of traditional & modern looks.

Fascia is used as a base to attach the roof guttering on to, or as a cover to hide the fixing space between the roof, eaves and wall. More than just functional, Fascia is designed to form a neat, attractive edge between the roofing and wall surface, as well as preventing birds and rodents from gaining entry to your roof cavity.

We have a wide range of round profile Colorsteel ™ downpipe to suit the colour and style of your roof. We also supply a complete range of downpipe elbows, T-junctions and mounting brackets. Available in 80mm and 100mm.

Chimney caps with or without a flu can be manufactured to meet customers' needs.

Custom rainwater heads can be manufactured to meet customers' needs. Available in Colorsteel, Zincalume and copper.

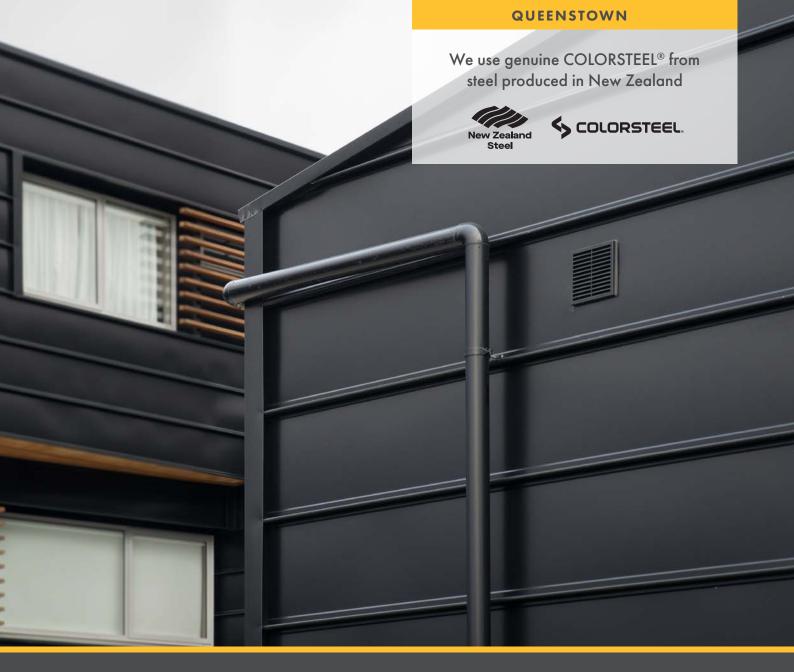
Quick to install, snap-on gutter brackets allow easy adjustment of gutter fall.

Custom manufactured to length, avoiding the need for joins in most applications.

Suitable for pitch roofs with flat soffits and roofs of up to 30° pitch with sloping soffits.

We also stock internal and external gutter brackets, as well as gutter stop ends and external gutter corners.
